115 North Duke Street

Fatal Natural Gas Explosion
Origin and Cause Investigation Report
Incident No. 19-1909574
April 10, 2019

Brian Graves
Assistant Fire Marshal
City of Durham Fire Department
August 2, 2019

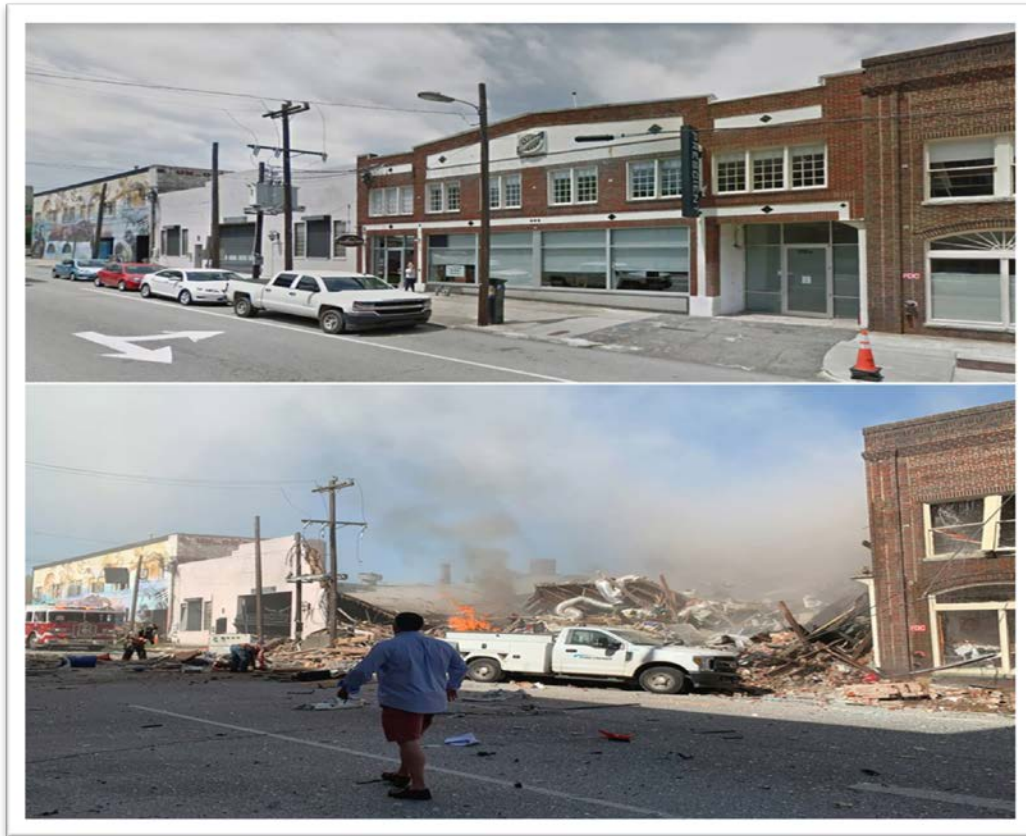
Figure 1 depicts 115 North Duke Street before and after the explosion.

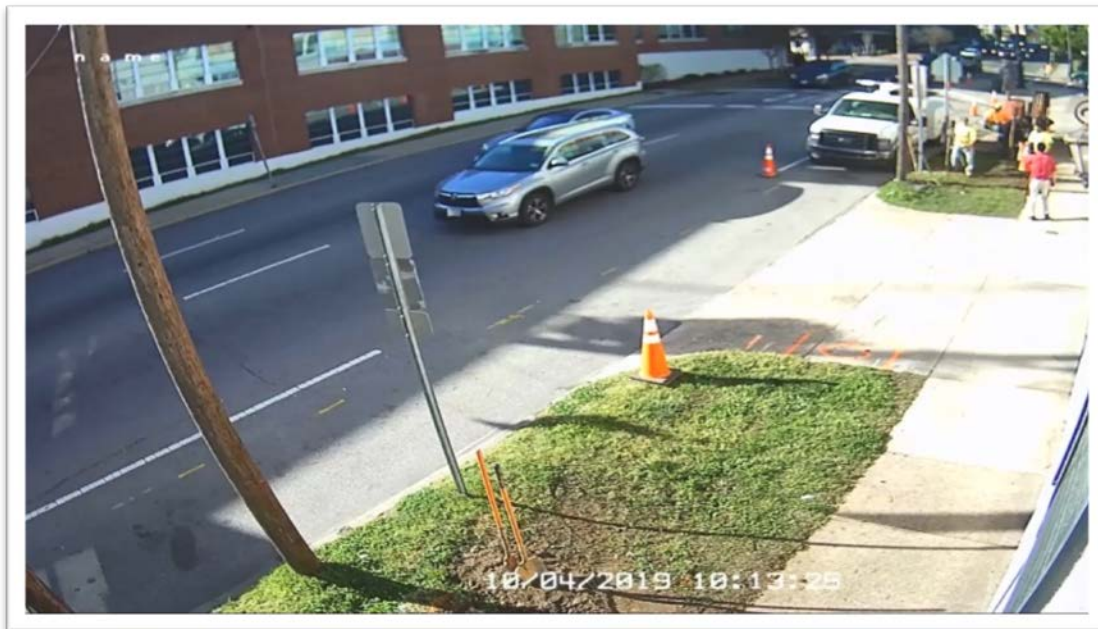
Moments after the gas leak and according to video footage, Mr. Lee of Kaffeinate appeared to be in discussion with employees of Optic Cable Technology LLC. Mr. Lee was observed fanning his hands by his nose to suggest the presence of an offensive or foul smell (Investigator's Note: The smell was likely the odorant mercaptan, having a rotting cabbage-like smell). After this brief exchange, Mr. Lee returned to his business.

Figure 2 depicts Mr. Lee approaching the Optic Cable workers about a foul smell at 09:07:25

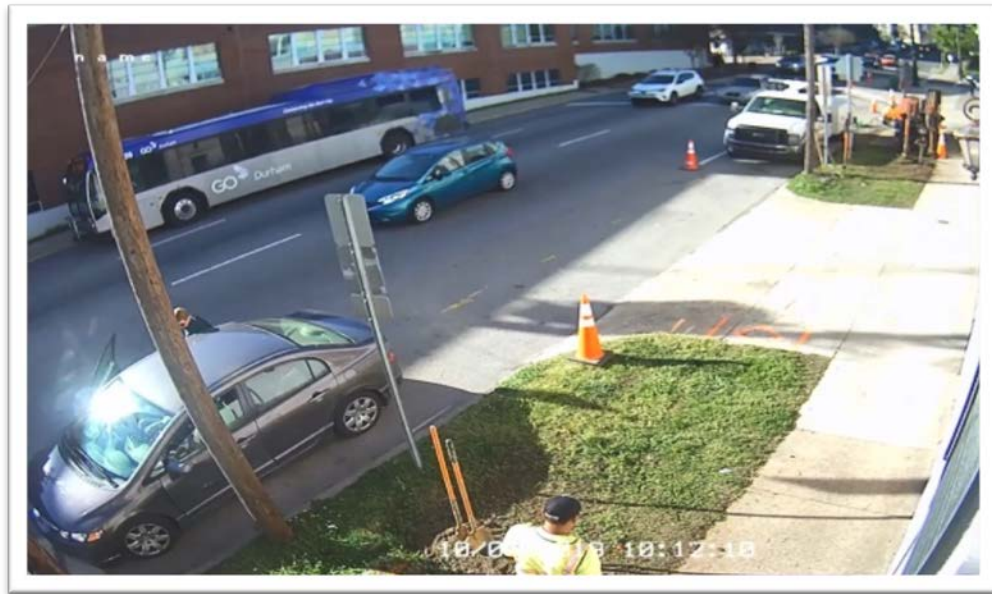
On April 10, 2019, at approximately 0906 hours (per video documentation), a ¾ inch gas line appears to be unintentionally breached which subsequently allowed fugitive gas to be released underground. This leak was discovered first by three employees of Optic Cable Technology LLC who were operating the equipment that struck the line. There is no evidence that any member of the Optic Cable Technology LLC crew called 911 reporting the breach.

Figure 3 depicts worker returning to drilling rig after gas line is struck. (0906 hours)

Gas Line Has Been Struck at 09:06:10 (all displayed times have a correction factor of -1h: 6mins)

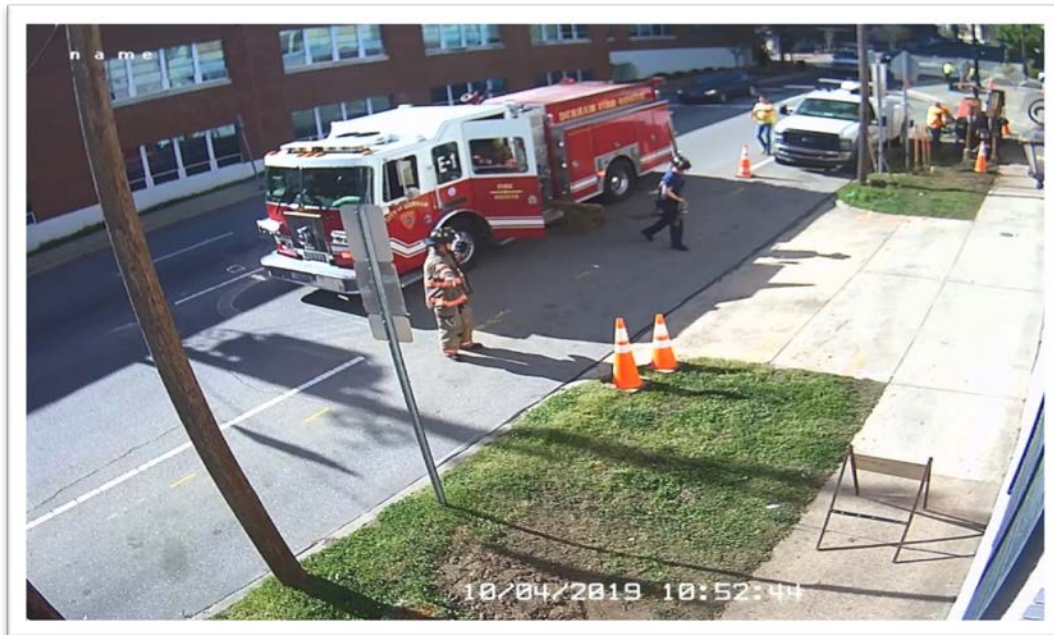
Figure 5 depicts Engine One arriving and establishing a hoseline.

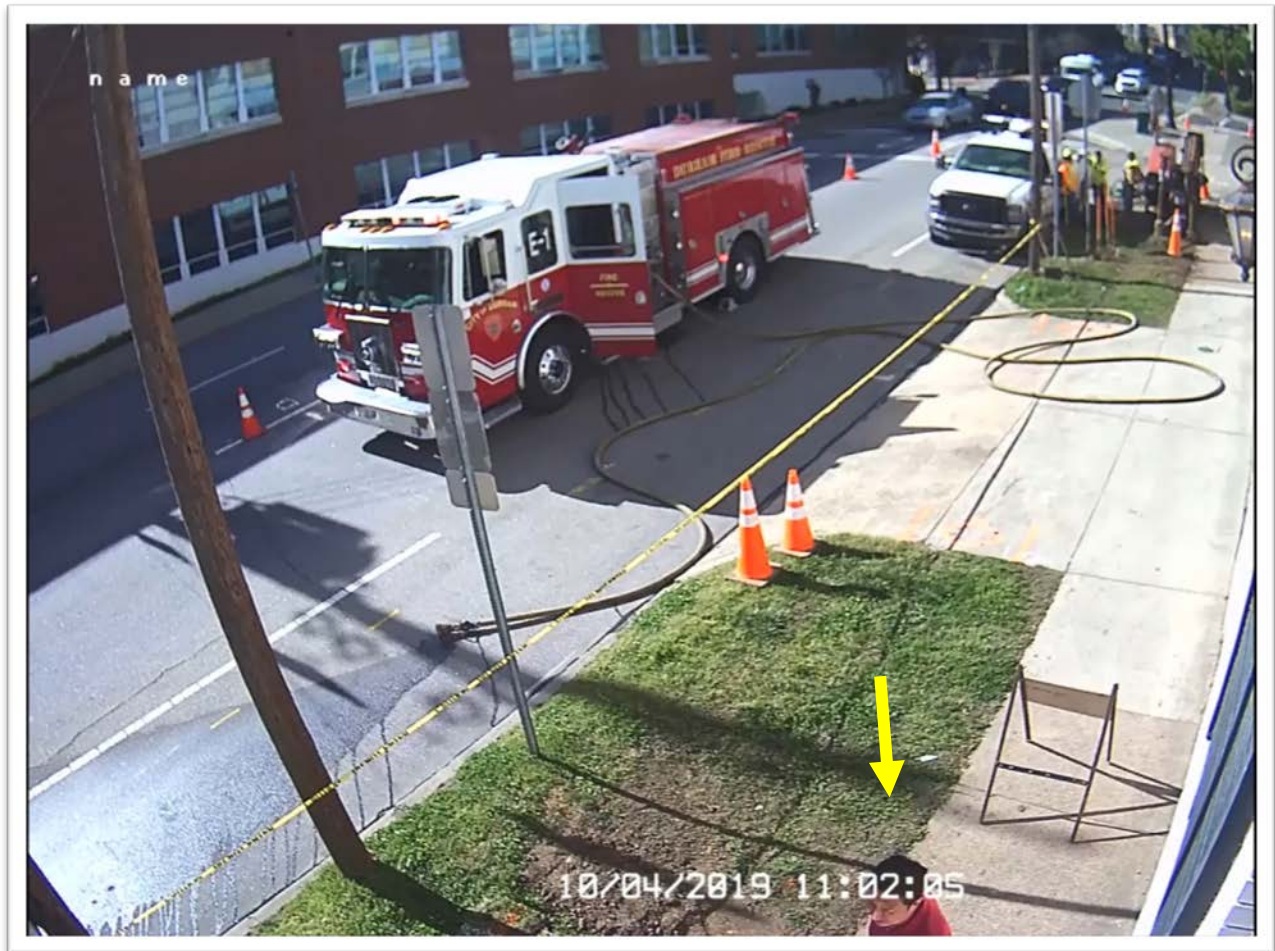
Figure 6 depicts Mr. Kong Lee while outside his business after Engine 1's arrival

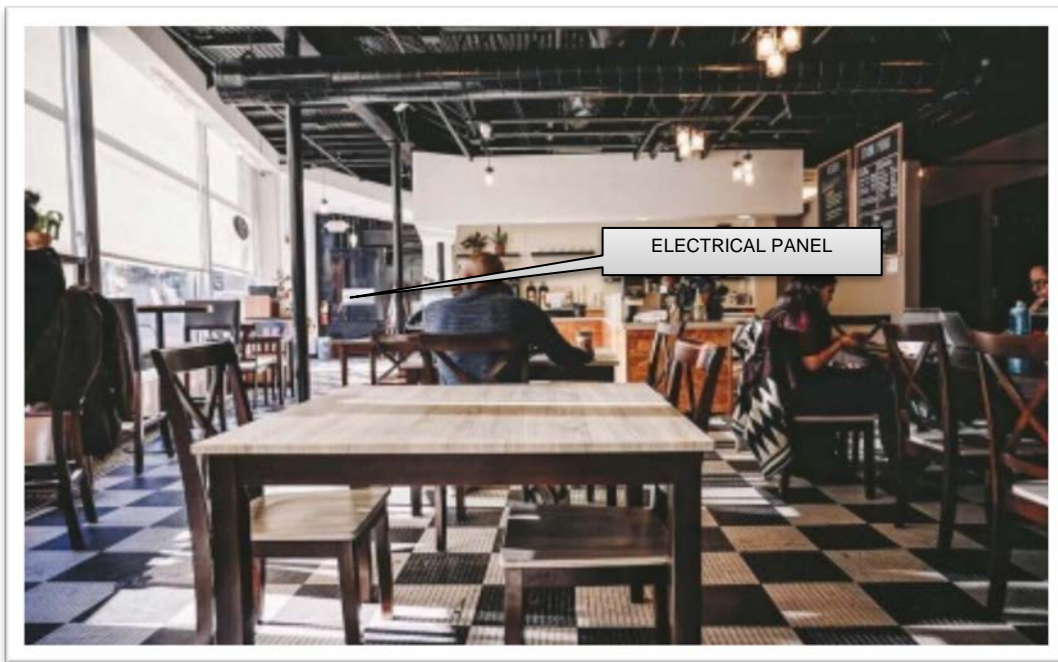
Figure 11 depicts the location of the electrical panel in Kaffeinate

The following are observations of the aforementioned electrical service:

- The events that ignited the explosive gas mixture could not be conclusively contributed to an electrical event in this panel.
- This electrical system was **not** Class 1, Division 1 or Division 2 (explosion proof wiring).
- The visual examination of the entire panel configuration did not reveal obvious modifications to the electrical systems.
- It is possible the electrical system in Kaffeinate was operable prior to the explosion with no known defect or failure. This opinion is based on the business operating in its normal condition and statements of an employee to firefighters and investigators.

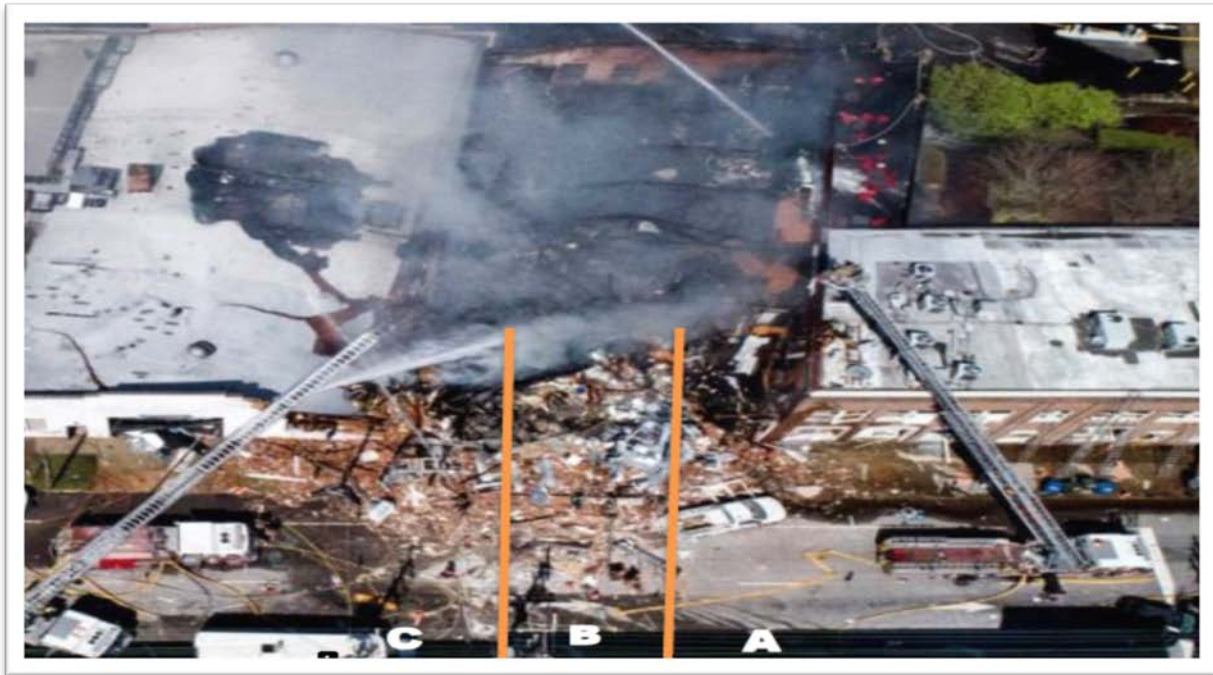
Figure 14 denotes debris examination areas

Investigators observed an intense area of burn approximately 30 feet in the rubble along the Bravo wall in section "C" west of Duke Street (Figure 14). This area was identified as a utensil wash area, based on prints (Appendix 5). Investigators conducted a guided excavation of this site to the tile floor. This area was excavated with an excavator having a bucket and thumb attachment, which allowed items to be picked rather than pulled. The area revealed items consistent with a utensil wash room. Stainless steel sinks and tables were discovered as well as various stored items. One noted item was a portable propane tank. The tank had

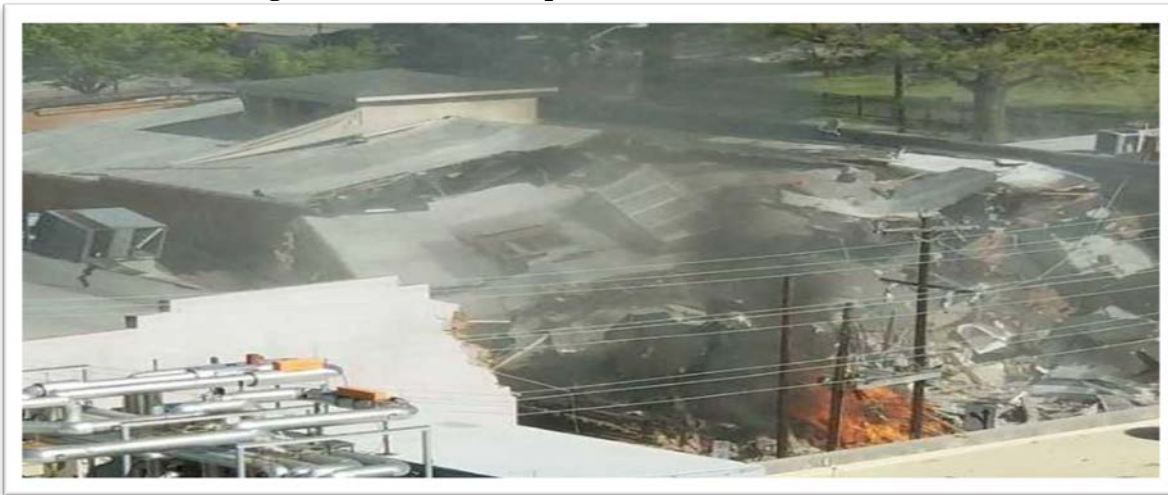
Figure 15 denotes the explosion site moments after blast

As illustrated in Figures 15 and 16, the initial blast force was concentrated at or around Kaffeinate. Two areas had gas fed fires; one localized around the gas meter on the Alpha side the second was near the Bravo side approximately 30 feet in the rubble pile under the collapsed roof. The fire then grew in intensity and spread to collapsed structural members. This fire could not be easily extinguished because access to the seat of the fire was concealed and gas fed. This allowed lateral spread and notable fire effects to the remainder of the structure. The fugitive gas flowing to this fire was eliminated by PSNC/Dominion Energy at approximately 1110 hours (Appendix 1, line 13a).

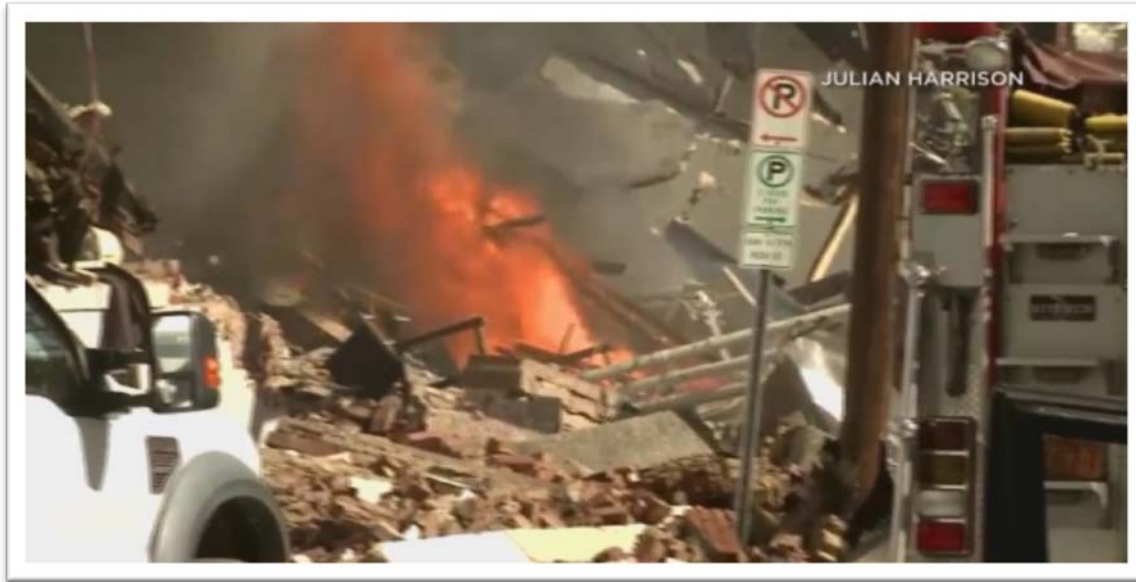
Figure 16 denotes the natural gas fed fire of the A/B wall

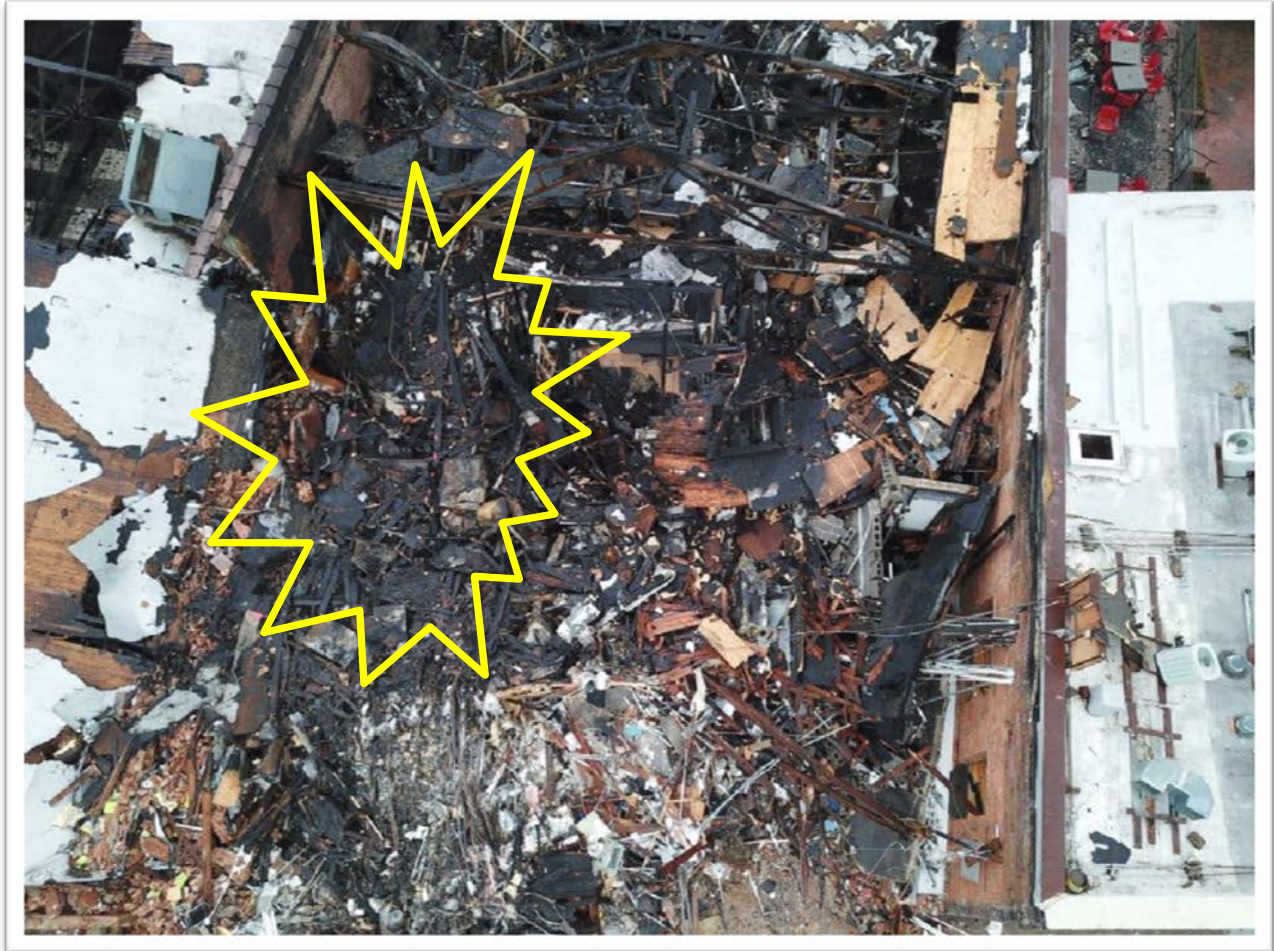
The natural gas flowed from the leak in the service line, through the ground, beneath the concrete and asphalt into the building and surrounding storm drains. The gas accumulated below the concrete and asphalt ground covering, restricting, and inhibiting vertical dissipation of the gas, and facilitating lateral travel of the gas toward and into the 115 North Duke Street building, adjacent buildings, and storm drains.

Figure 18 denotes a possible migration path of the fugitive gas

2. A possible gas migration area was located approximately 30 feet along the Bravo wall. It is acknowledged that gas migrated underground and permeated 115 North Duke Street creating an explosive fuel air mixture. The structure's building elements created a moisture tight ensemble, but not vapor tight. There were numerous building components that could allow the fugitive gas to permeate this space.
